# Manhole Inspection Summary

Manhole # S69Q\_\_002MH

Insp Date: **4/17/08 10:27 AM**

**Location** Address: **1607 Dundalk Ave.**

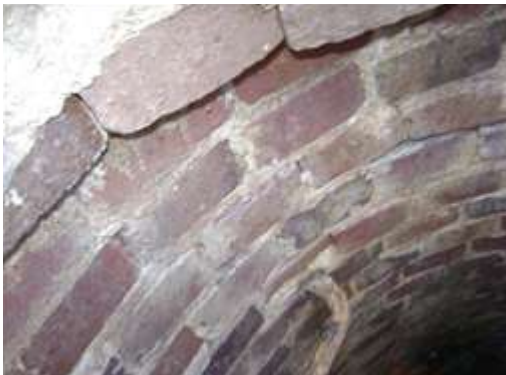
Defect 1

Condition: ☐ Sound ☐ Cracked ☐ Root Intrusion ☒ **Loose Brick** ☒ **Deteriorated**

loose bricks

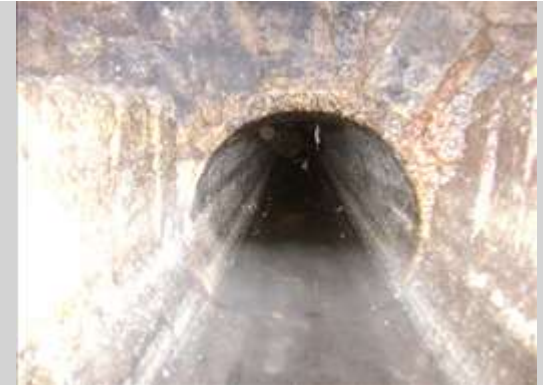
12 O'Clock Outflow

8 in. Circular Gravity Sewer  
Pipe Out @ 12 O'Clock

Pipe Height: **8.4** (in.) Rod and Bar (Angled)  
Pipe Material: **Clay** ☐ Pipe Lined  
Invert Depth: **8.46** (ft.) Flow Characteristics: **Slow**  
Deposits: ☐ None ☐ Mud ☒ **Sludge** ☐ Debris ☐ Grease  
Silt Depth: **0.25** (in.) Deposits Extent: **Light**  
Infiltration: **None** Pipe Seal Cond: **Sound**

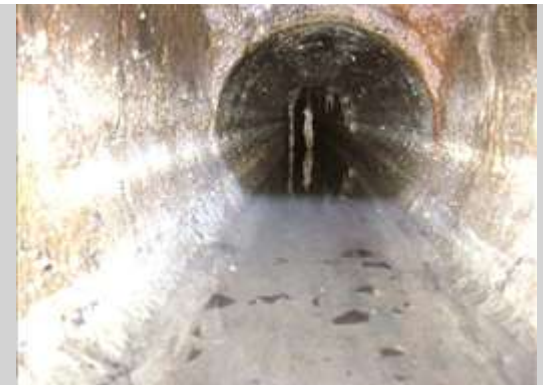
6 O'Clock Inflow

8 in. Circular Gravity Sewer  
Pipe In @ 6 O'Clock

Pipe Height: **8.4** (in.) Rod and Bar (Angled)  
Pipe Material: **Clay** ☐ Pipe Lined  
Invert Depth: **8.42** (ft.) Flow Characteristics: **Slow**  
Deposits: ☐ None ☐ Mud ☒ **Sludge** ☐ Debris ☐ Grease  
Silt Depth: **0.25** (in.) Deposits Extent: **Light**  
Infiltration: **None** Pipe Seal Cond: **Sound**
